CHANNEL EROSION on the MISSOURI RIVER, MONTANA between FORT PECK DAM and the NORTH DAKOTA BORDER

USDA-Agricultural Research Service
National Sedimentation Laboratory
Oxford, Mississippi

Coordinated Resource Management Group - Lower Missouri River CRM
Culbertson, Montana

May 1999

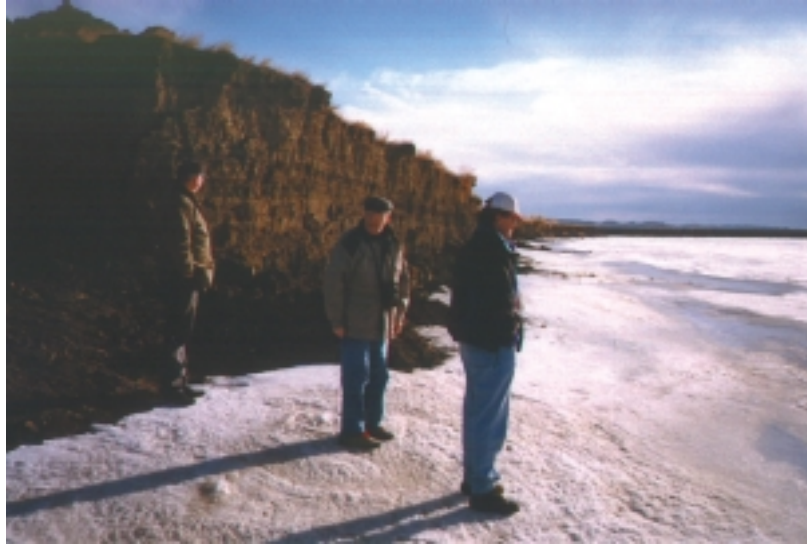
Figure 91--The lower Missouri River at River Mile1624, February 10, 1998. As at many other locations along the river, an eroding bank and shifting channel are in direct contact with river ice.

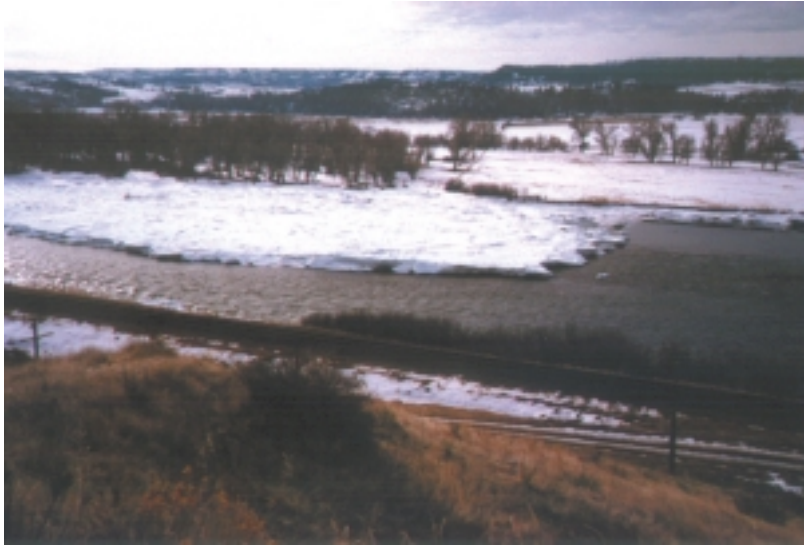
Figure 96--The remnants of a freeze-up jam in the Yellowstone River, Montana, February 9, 1998. The jam comprised frazil slush and pans, mixed with snow, and it is partially grounded.

depicted by Figure 96 for the Yellowstone River. His description nicely captures the way in which ice may grip a river:

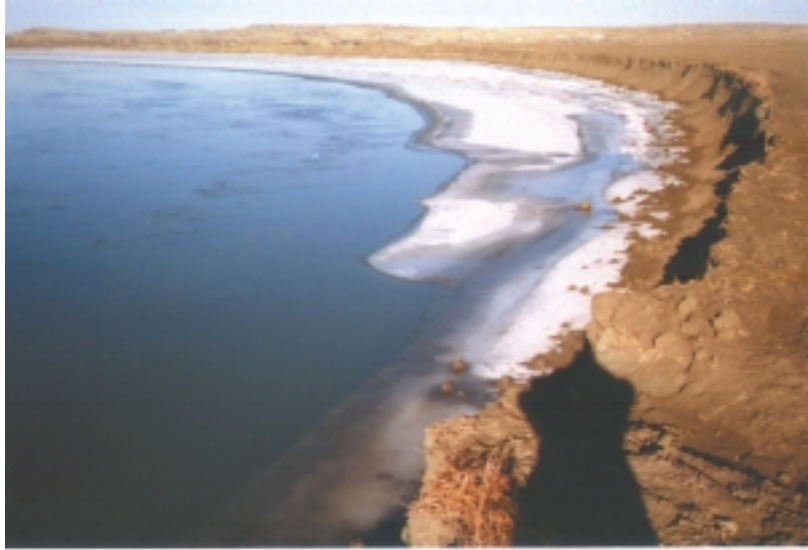
Figure 99--Border ice growth developing from the north bank of the lower Missouri River near River Mile 1624, February 10, 1998. Note that slight fluctuations in flow elevation have caused several layers of growth.

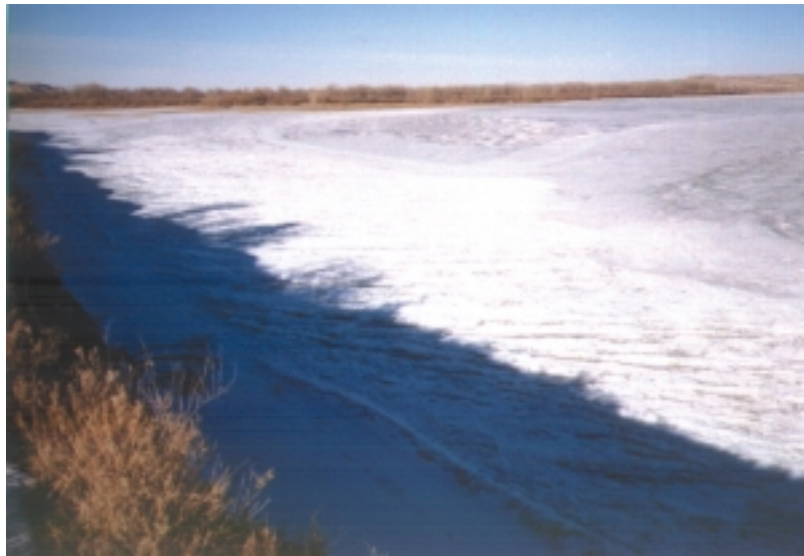
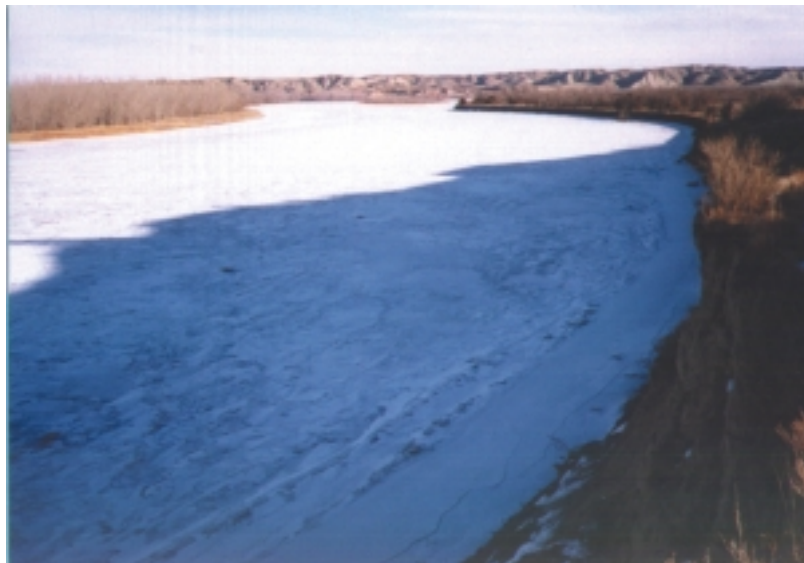
Figure 100--Ice formation on the lower Missouri River in the vicinity of River Mile 1622 (downstream of the Tveit-Johnson site), February 10, 1998; (A) view upstream, and (B) view downstream. The ice cover comprises border ice along the bank in the foreground and around the bars. It also comprises accumulated frazil slush and pans along the main thalweg of the channel. The accumulation ridges in the center of the top figure indicate how frazil slush and pans accumulated to form the cover.

Most of the typical features of ice formation on the lower Missouri River are evident in any of its reaches. Figure 99, for instance, depicts border ice growth along the northern bank of the river near River Mile 1624. The reach between River Mile 1623 and River Mile 1622 (just downstream of the Tveit-Johnson Site and conveniently viewed from a local road elevated along a bluff) is depicted in Figures 100a and b. It is representative of the river. The processes of border-ice growth, ice accumulation and cover solidification are evident in Figures 100 a and b, which give upstream and downstream views of the reach during mid-February 1998.

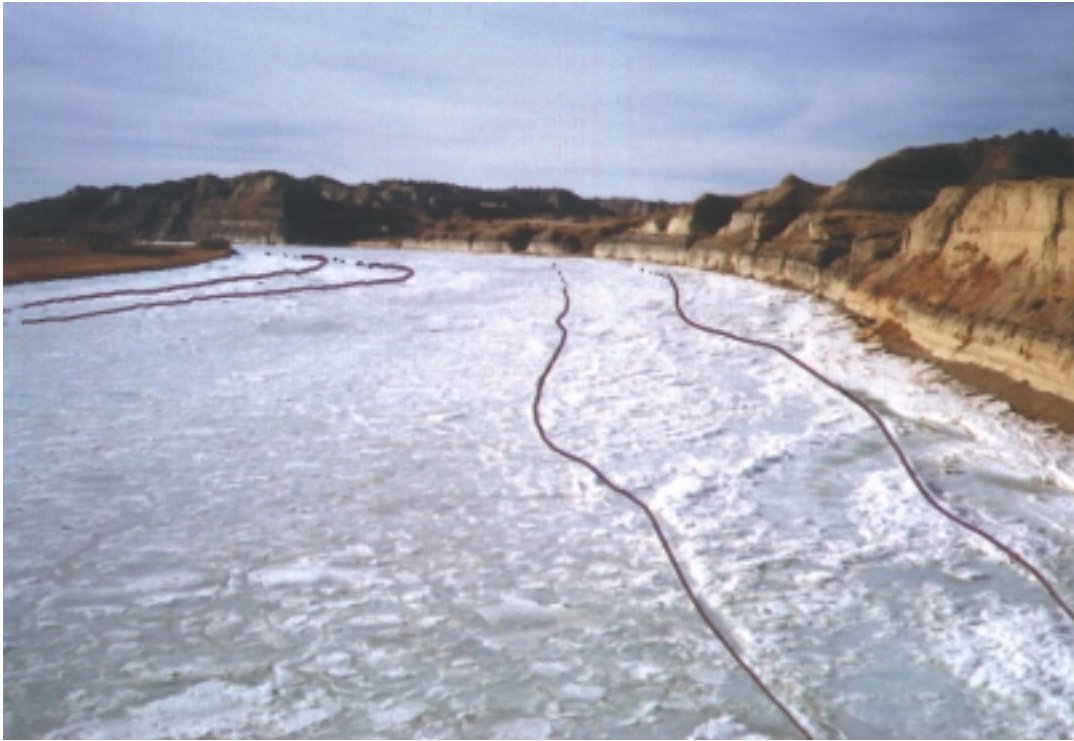
Figure 107--Lateral changes in flow area complicate estimation of sediment transport rates in an ice-covered river, such as the Yellowstone River shown here. The lines indicate how the flow area reduced laterally as the cover formed.

Alterations in flow distribution complicate evaluation of ice-cover effects on transport rates for many. This difficulty is evident in Figure 107, which shows an ice cover over the Yellowstone River, near Fallon, Montana, and from figures such as Figure 105, which shows non-uniform ice accumulation across the Tanana River. The series of shear lines in the ice cover marked on Figure 107 indicates how the flow area has gradually narrowed. Flow-width alteration is more difficult to predict than flow depth change due to ice. The formation of sub channels within an ice-covered channel may accentuate narrowing of the flow area, especially if the channel is not prismatic. The sub channels form when accumulations of frazil slush or other ice pieces develop under the ice cover. In effect, they duct the flow in a manner that significantly alters the flow distribution from that attributable to the imposition of a level ice cover.

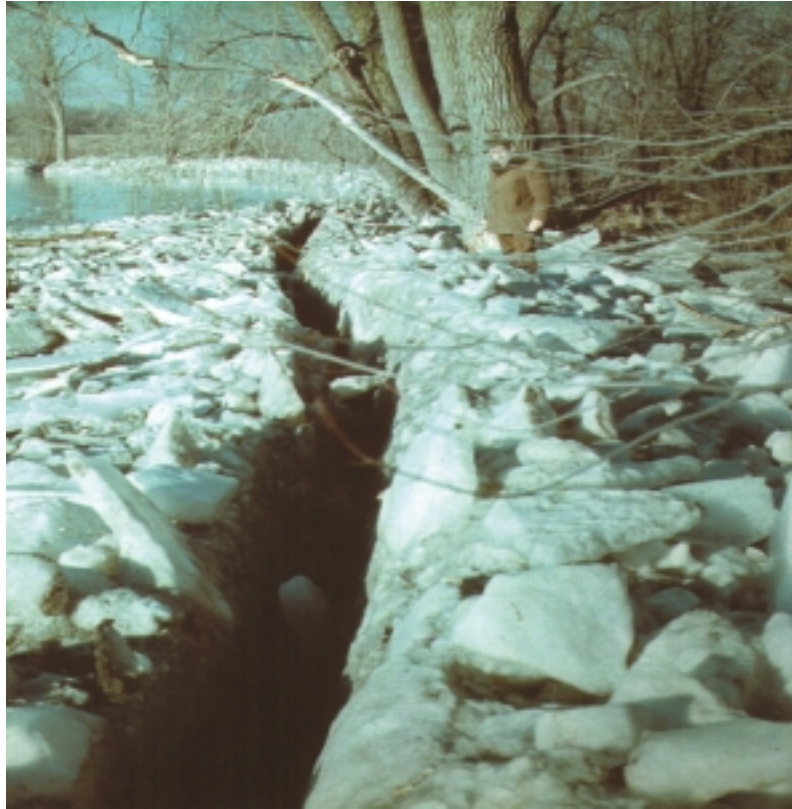
Figure 114. A shear plane often separates moving ice and a layer of ice pressed against a riverbank. Though the shear plane may partially protect the upper portion of the bank, moving ice may erode the bank toe.

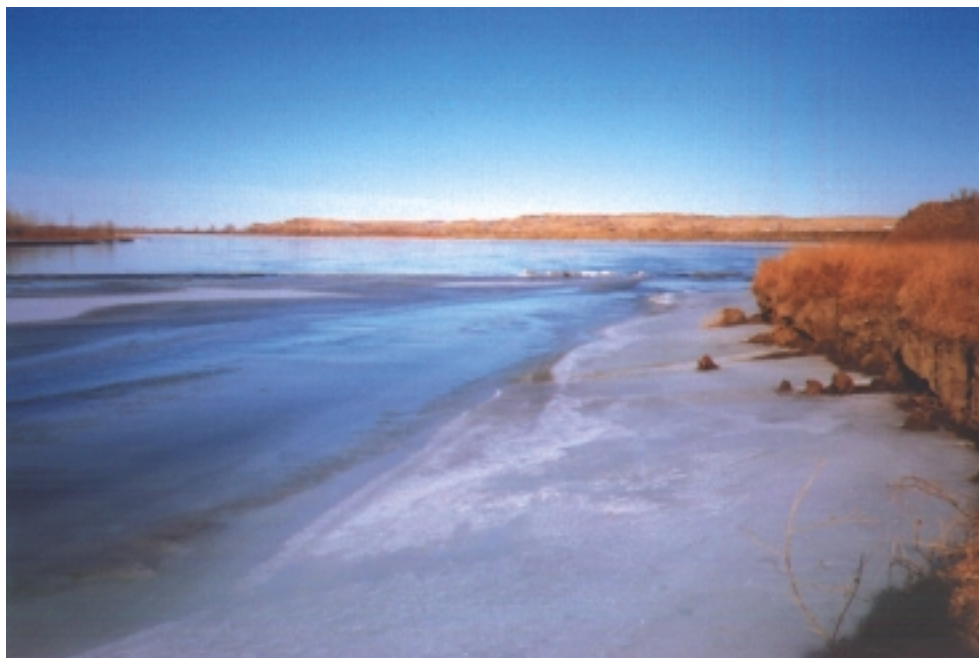
Figure 117--Sagging and rotation of the ice cover at about River Mile 1624, near the Tveit-Johnson site, February 10, 1998.

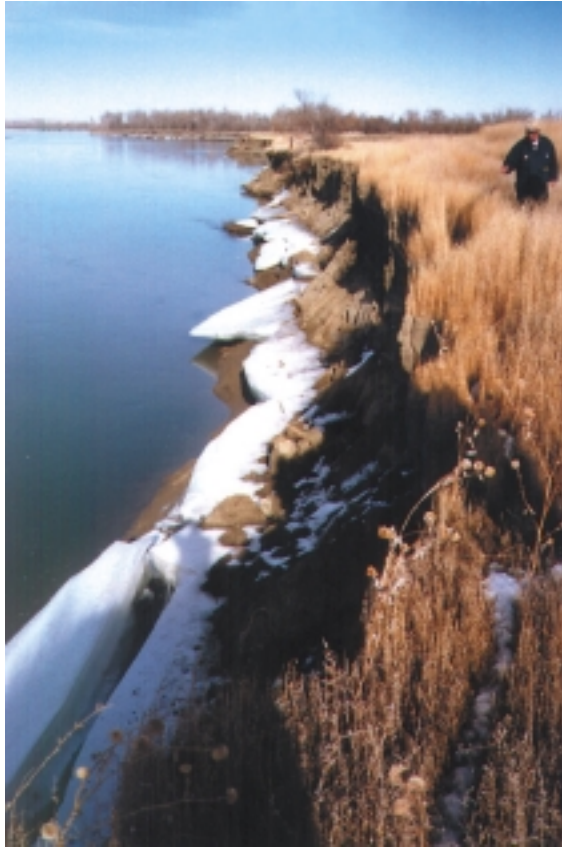
Figure 118--Rotation and collapse of elevated border ice in the vicinity of River Mile 1716, near the Pipal site.

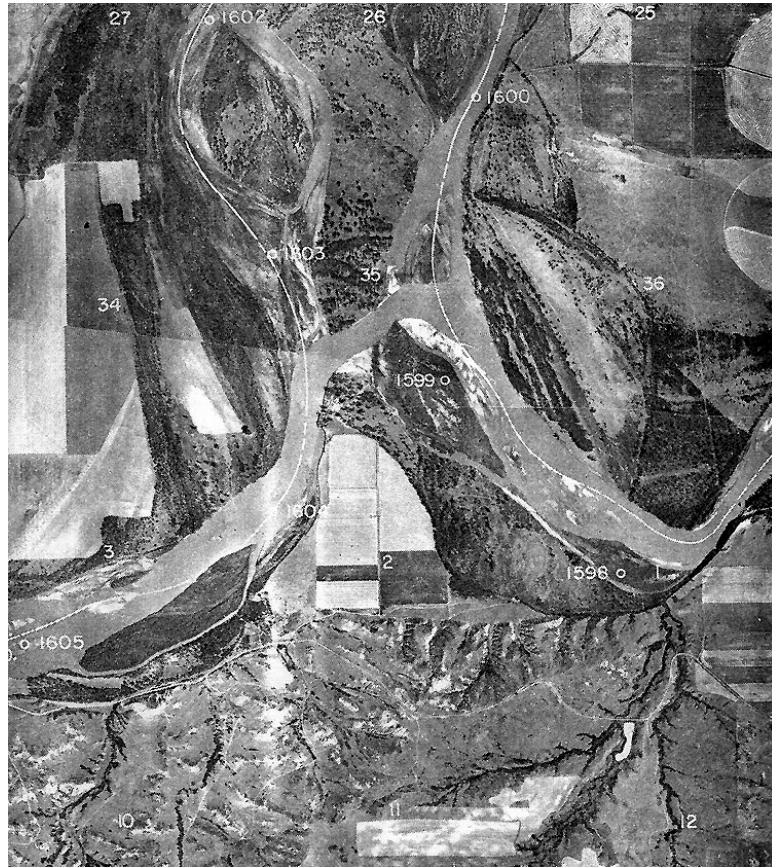
Figure 119—River Mile 1603, a reach where an ice jam resulted in a meander-loop cutoff.

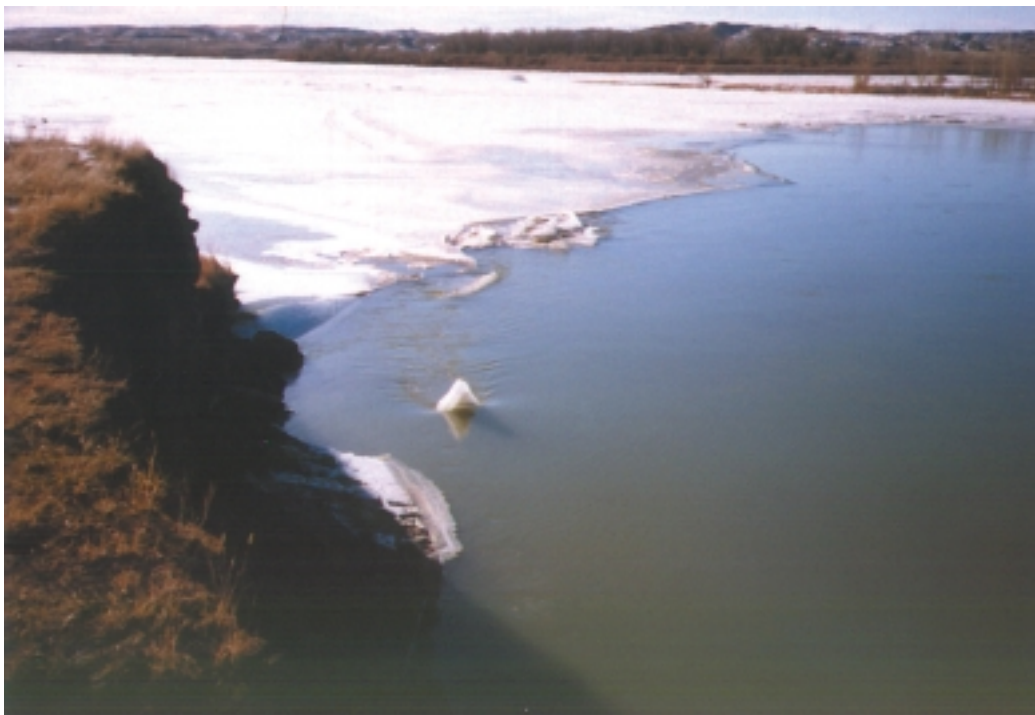
Figure 120--Ice pieces collecting at the head of an ice cover locally increase flow velocities near the bank.

Figure 120 shows one circumstance. The head of the ice cover at about River Mile 1624 (in the vicinity of the Tveit-Johnson site) coincides with the downstream end of a bank-erosion arc. Pieces of drifting ice, together with ice broken from the sagged ice cover (cover sagging had occurred due to a reduction in river flow), locally increased water velocities near the bank. Though the site visit was not long enough to monitor for accelerated bank erosion, the configuration of ice at this location could likely accelerate lengthening of the eroding bank, especially if flow increases. An important aspect of the present observation is that the location of the head of an ice cover within a complex channel may accelerate channel shifting by locally altering flow resistance and direction. This bank-erosion mechanism (if it is indeed significant) has never before been investigated.

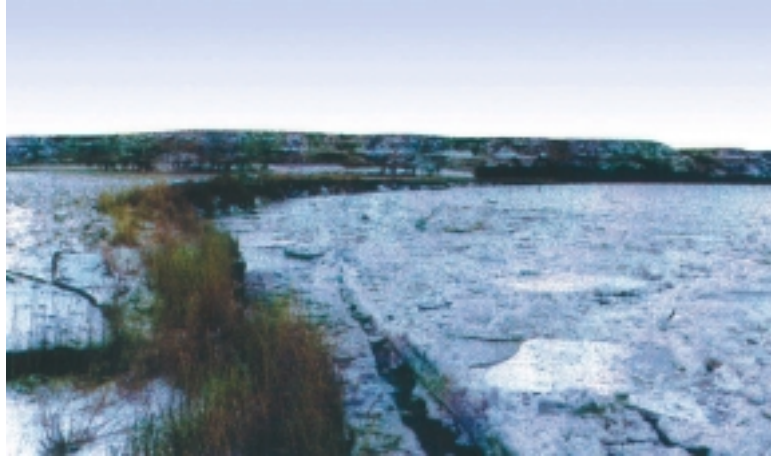
Figure 121--A thick layer of broken ice moves slowly downstream in the vicinity of River Mile 1631, near the Vournas site.

Moving ice may gouge and abrade the banks of the lower Missouri River along certain reaches of the river. Figure 121, for instance, depicts a thick layer of ice moving through the river at about River Mile 1631. However, because ice-cover breakup in the lower Missouri River apparently is a rather gentle process, gouging and abrasion of the river's banks likely are not as severe as may occur for other rivers, such as the Yellowstone River, in which ice-cover breakup and ice jam formation are more dramatic. Other than the instance depicted in Figure 121, there seems to be little information available with which to assess the significance of ice gouging and abrasion. All that can be said is that, when it occurs, it is another factor that aggravates bank erosion.

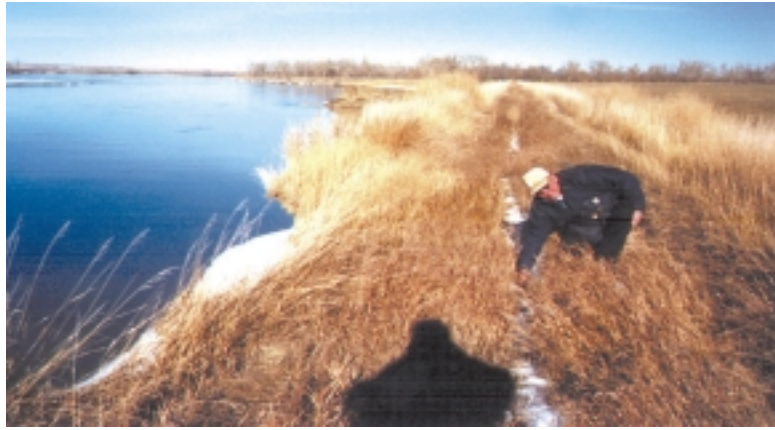
Figure 131--Crack development along the riverbank crest near River Mile 1716, the Pipal site.

Ice-wedge formation accelerates the detachment of large blocks of bank. The large crack shown in Figure 131 probably developed due to an overall structural weakening of the bank. Once formed, however, the crack would be weakened further by freeze-thawing of accumulated water, which would weaken soil surrounding the crack and cause it to enlarge. In this regard, frigid winter conditions may not slow bank erosion, or at least it may not significantly slow the deterioration of a bank.

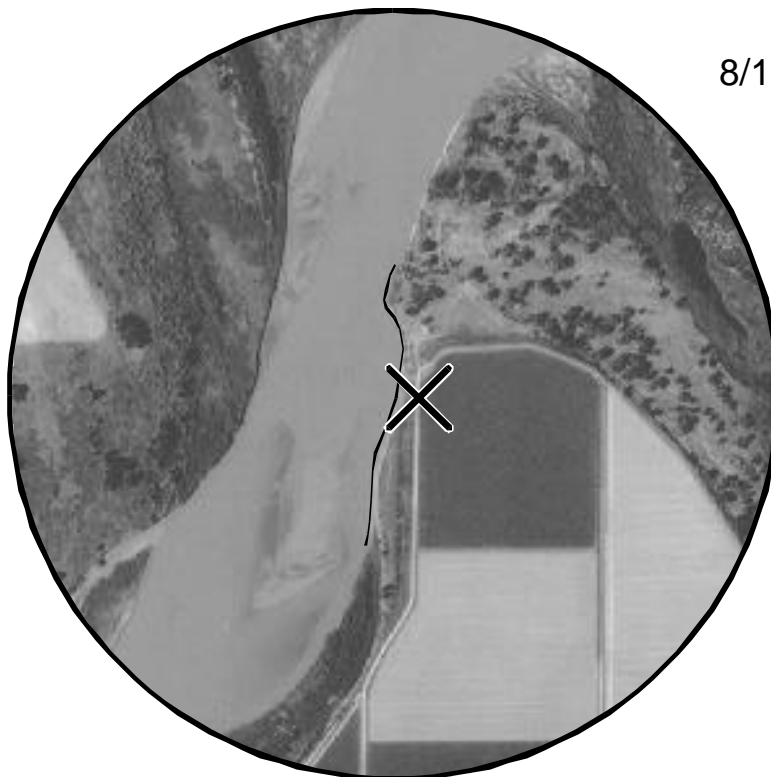
U.S. Geological Survey topographic map and National High Altitude Photography Program coverage of local erosion rate site 2, RM1604 (Hardy site).

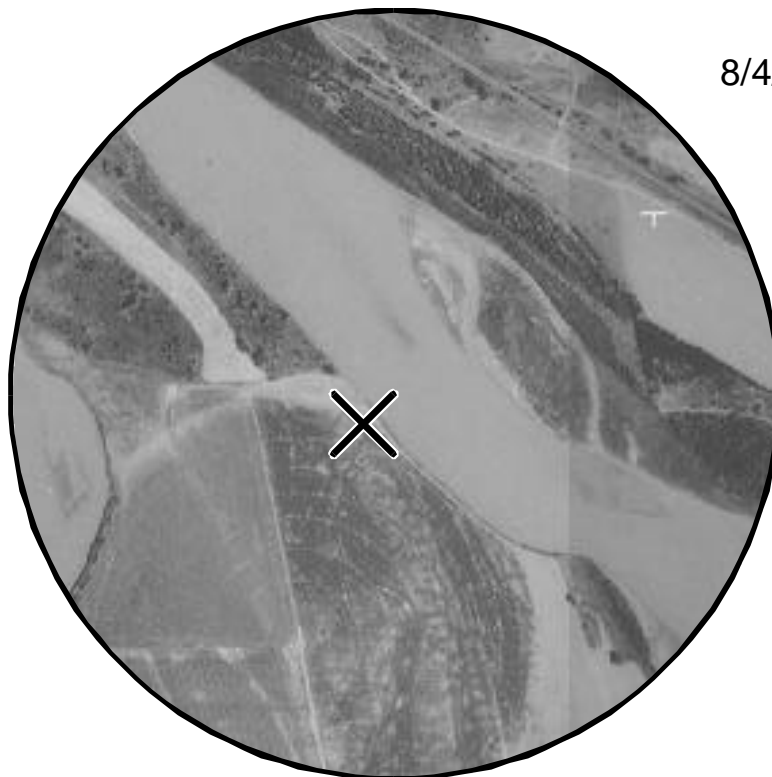
U.S. Geological Survey topographic map and National High Altitude Photography Program coverage of local erosion rate site 6, RM 1630 (Iverson site).

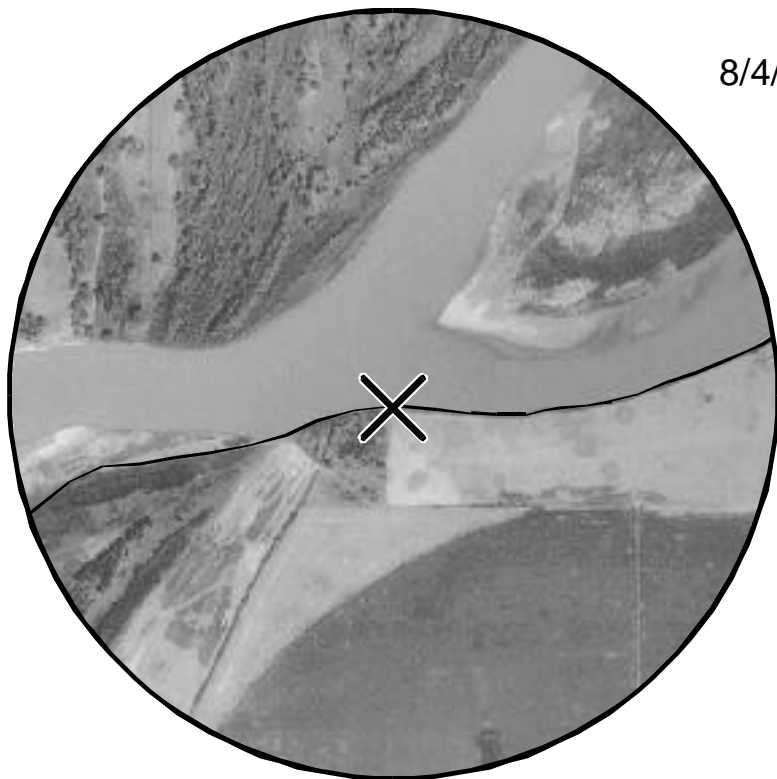
U.S. Geological Survey topographic map and National High Altitude Photography Program coverage of local erosion rate site 7, RM 1631 (Vournassite).

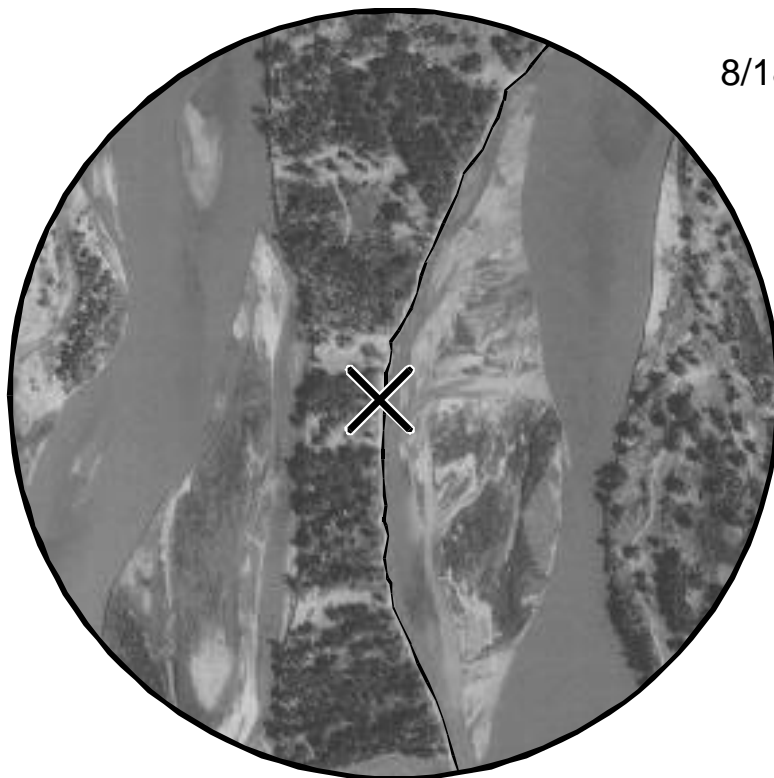
U.S. Geological Survey topographic map and National High Altitude Photography Program coverage of local erosion rates site 9, RM1676 (Woods Peninsula site).

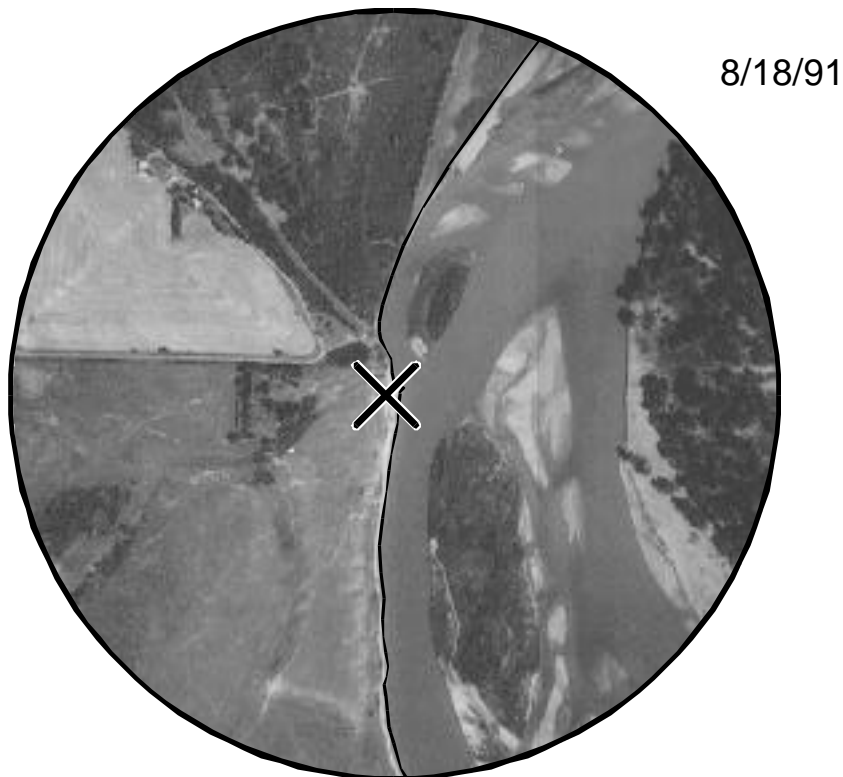
U.S. Geological Survey topographic map and National High Altitude Photography Program coverage of local erosion rate site 10, RM1682 (McCræ site).

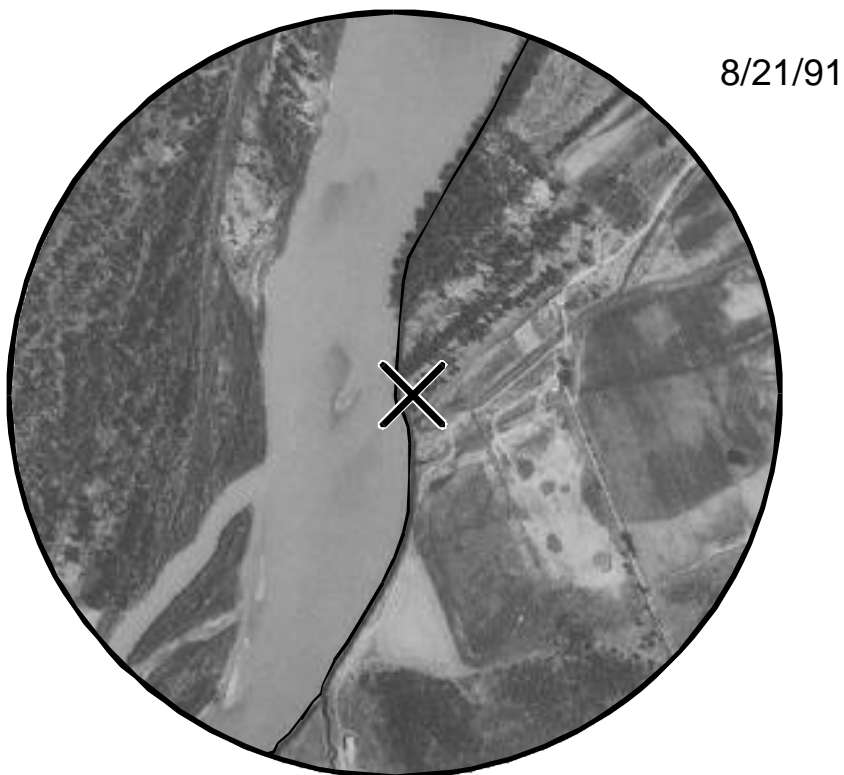
U.S. Geological Survey topographic map and National High Altitude Photography Program coverage of local erosion rate site 11 RM 1701 (Wolf Point site).

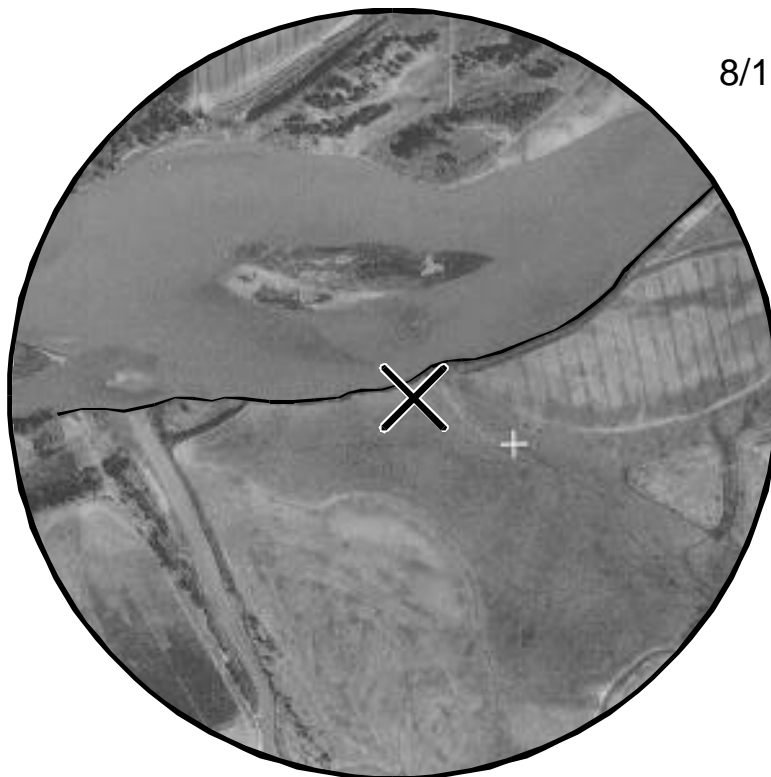
U.S. Geological Survey topographic map and National High Altitude Photography Program coverage of local erosion rate site 11.5, RM 1716 (Pipal site).
